# Infrastructure development recommendation for traditional market to promote economic growth: A case study of Landungsari traditional market

*How to cite:* Kumalasari, A., & Cahyani, R. A. T. (2023). Infrastructure development recommendation for traditional market to promote economic growth: A case study of Landungsari traditional market. *Journal of Community Service and Empowerment*, 4(3), 536-544. <https://doi.org/10.22219/jcse.v4i3.26774>

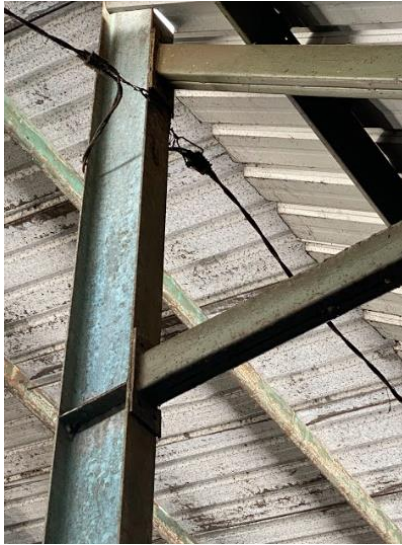
Figure 3. The corroded structural steel

The building's structural elements in the Traditional Market of Landungsari are generally in good shape, however some of them require maintenance. The market stalls' structural steel, which are depicted in **Figure 3**, are affected by corrosion damage. It can be caused by exposure to the environment and inadequate corrosion protection. The severe corrosion damage on a steel structure can reduces its loading capacity, even leading to structural collapse (Luo et al., 2020). Since the steel structure itself is still in good condition, the preventive measures can be taken by remove corrosion using sand blasting, followed by applying a protective coating on the steel section.

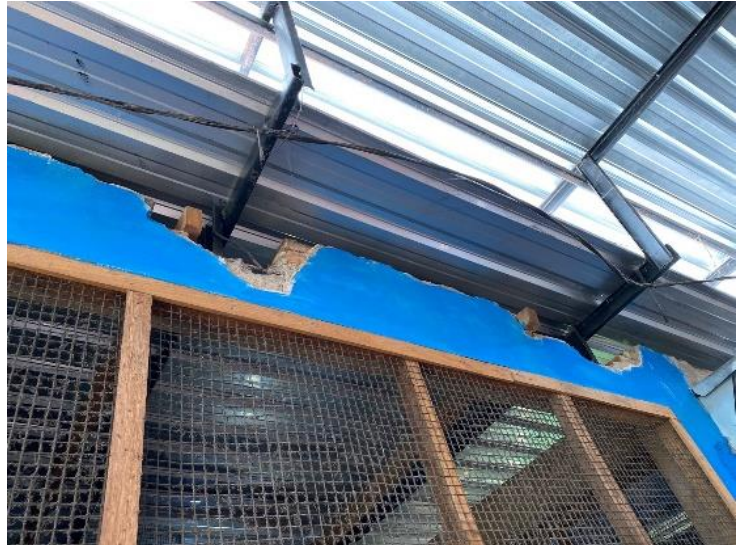
Figure 4. Market stall's wall with large opening

The visual inspection discovered that most of the market's stall walls have no significant damage that could affect its strength and stability. However, some of it needs to be fixed. **Figure 4** shows a brick wall with a sizable opening on top that was likely built to accommodate roof beams. This kind of damage can be easily repaired by rebuilding the section of the wall that has the opening.

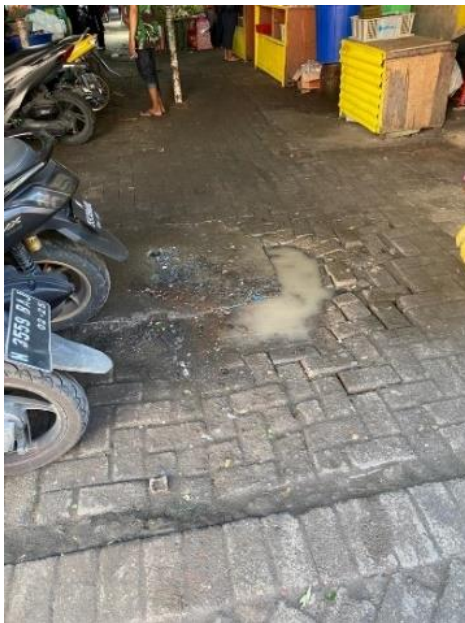
Figure 5. The sunken pavers at the market aisle

The Traditional Market in Landungsari has two different types of flooring: paver brick flooring for the aisle between the market stalls and plastered floors in the market stalls. Visual assessment revealed that the majority of the plastered floors are in decent condition. However, some sections of the paver on the aisle sunk down, causing a tripping hazard, and forming puddles of water (**Figure 5**). Typically, poor installation, soil erosion, or a drainage problem cause pavers to sink

(Hening et al., 2021). It may also indicate that the base was not properly compacted during construction. Since sinking pavers caused problems, both aesthetically and structurally, it is recommended to repair the pavers by reinstalling them after thoroughly identifying the underlying issues.

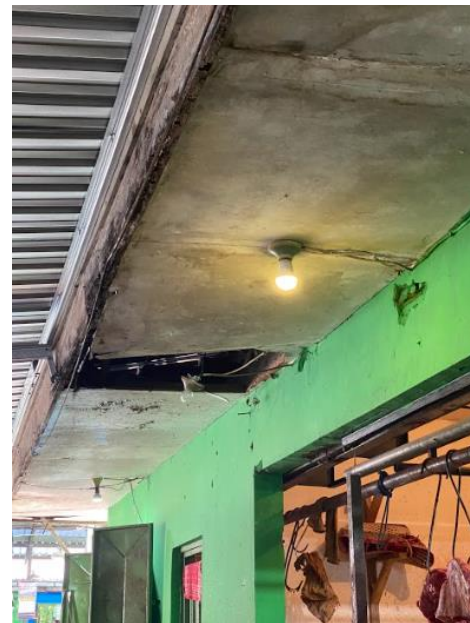
Figure 6. The damaged ceiling in market stalls

The finishing elements that require immediate attention is the ceiling. In some areas of the market stalls, the damage is quite severe as the ceiling has collapsed while other parts are sagging (**Figure 6**). A sagging ceiling poses an immediate hazard since it could collapse and put both the buyer and seller at risk. The common cause of saggy ceilings is water damage, inadequate support, or simply wear out with age (Z et al., 2019). Another factor is the lack of maintenance provided. It is suggested to replace the ceiling with a new one since the damage is severe. Additionally, it is advised to inspect for potential water damage and add new support under the ceiling.

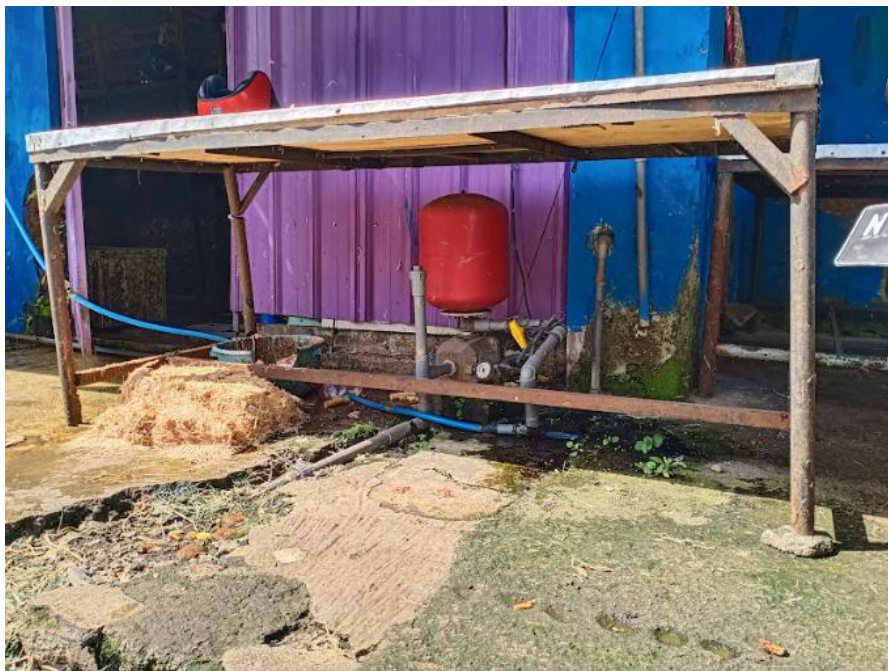
Utilities infrastructures supply utility services to the public and considered to include electricity, gas, water, sewage, drainage, and life-safety system. In the Traditional Market in Landungsari, traders have proper access to electricity and clean water. The water is accessed using bore, either provided by the market or by the trader itself (**Figure 7**). However, bore water not be preferable for drinking or cooking without properly tested or treated (Shyamala et al., 2008). Therefore, it is advised to evaluate the quality of the groundwater in this market area.

Figure 7. Access to groundwater using a bore

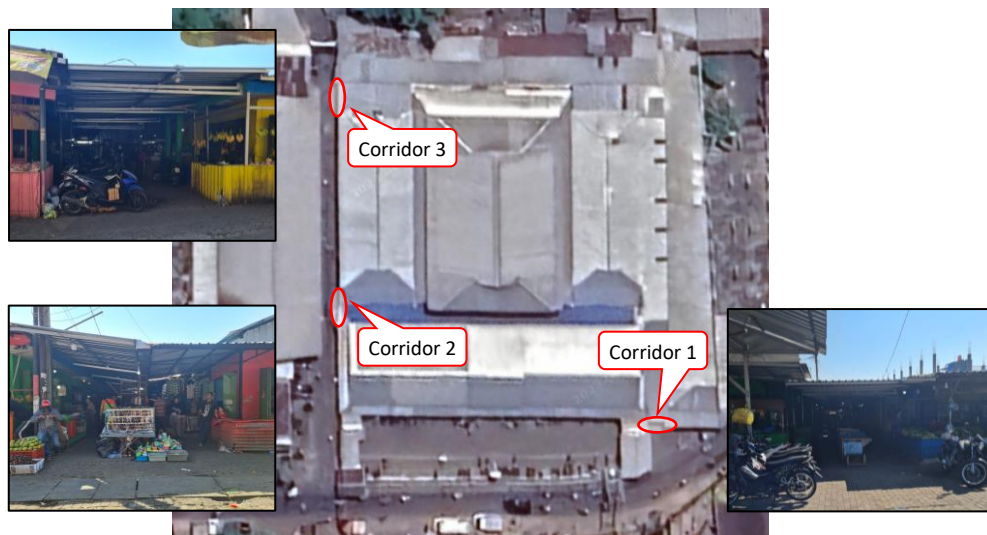
**Figure 9.** Three corridors as the entrance and exit points for the market's building

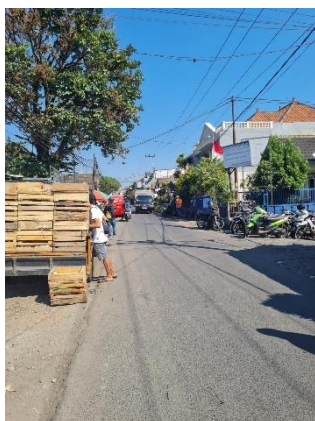
The Traditional Market of Landungsari has provided adequate access to the market's building. There are two roads that lead to the market, Jalan Tirto Rahayu and Jalan Tirtomoyo (**Figure 8**). However, as can be seen from **Figure 10**, the road width of Jalan Tirto Rahayu is not wide enough for two cars to pass (only about three meters wide). Moreover, the other access from Jalan Tirtomoyo is only suitable for motorcycles and pedestrians (**Figure 11**). Jalan Tirto Rahayu, the main road, has two main entrances to the market (Gate A and B), while Jalan Tirtomoyo has one back entrance (Gate C) (**Figure 8**). Three corridors serve as the entrance and exit points for the market's building (**Figure 9**). With a width of about 3.5 meters, these corridors are wide enough to accommodate the trading activities of the market. However, observation revealed that there was no public transportation available around the market and the majority of the market's visitors uses motorcycles as the transport mode. Lack of access to public transportation may impede accessibility and discourage residents of wider areas from visiting the market (Berg & Ihlström, 2019; Widayanti & Supriyatno, 2020).

**Figure 10.** Jalan Tirta Rahayu, the primary road access to the Landungsari Market

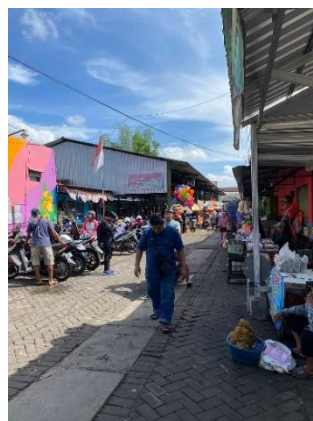
**Figure 11.** Jalan Tirtomoyo's narrow width restricts traffic to only motorcycles and pedestrians

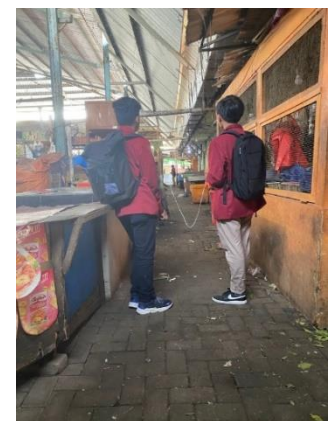
According to the standard, the aisle between the two stalls in the market must be at least 1.5 meters in width to ensure the ease of the people walking around the market. This requirement has not been met as the market's aisle is around one meter in width (Figure 12). This narrow corridor leads to congregated and overcrowded people in some areas during the rush hours. The inadequate space in the aisle not only threatens the shopping convenience but also poses a danger in case of emergencies. A market with high accessibility needs to provide wheelchair access to all parts of the market. The Traditional Market of Landungsari has a narrow aisle with rugged and uneven paver floors, which is not suitable for wheelchair mobility. Additionally, there are no disabled facilities, such as toilets and parking spaces designed for people with mobility impairments. The evaluation result of the Landungsari market's accessibility is summarized in Table 4.

**Figure 12.** Narrow aisle between two stalls in Landungsari Market

From Table 4, it is found that there are three indicators that must be improved to increase the market's accessibility: the width of the market's aisle, accessible space for wheelchair mobility, and the establishment of public transportation services. Since the ease of accessing the market and its facilities contributes greatly towards the market's sustainable growth, it is preferable to address this problem in the market's development plan.
